SAFETY BULLETIN

Safety at Survey Sites

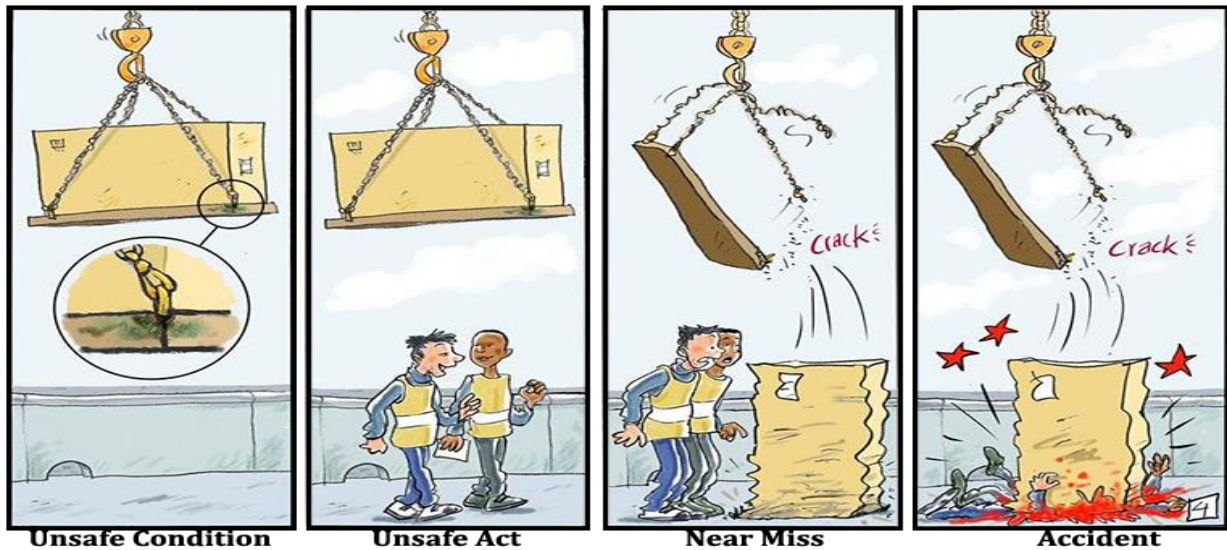
- *Wooden planks provided for working at height not properly secured*
- *No proper lighting provided inside the tank*

In all instances attending surveyor had to wait for rectification of above safety issues before proceeding for inspection. Noted the lapses are of a recurrent nature at some yards.

- ❖ It is advised to have regular meetings with Shipyard management to review safety procedures & appraise them of lapses in safety related matters to avoid any untoward incident.
- ❖ Surveyors to be always vigilant for unsafe acts/practices
